AquaRockBag® project report: Yearls Weir River Derwent

Yearls Weir River Derwent

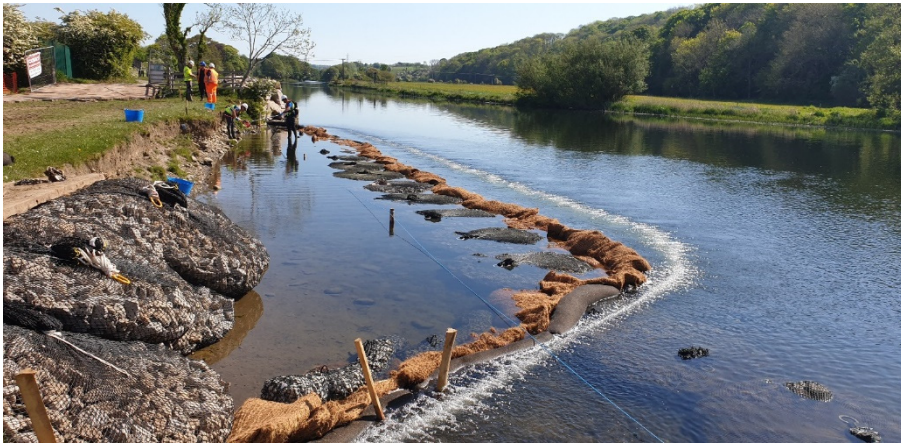
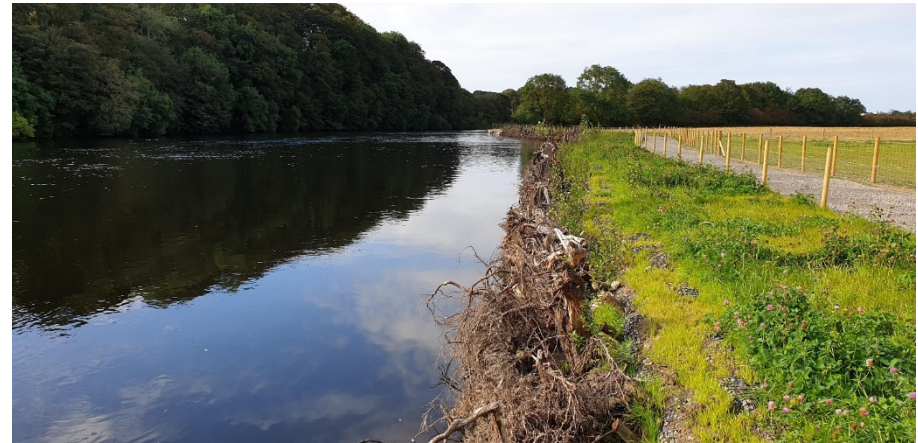
Following two major floodings (winters of 2009 & 2015) increased erosion had impacted upon key assets:

- Access track to the south of Yearl Pumping Station
- Bank between Yearl Weir and Yearl Weir Pumping Station
- Bank immediately upstream of Yearl Weir, threatening the structural stability of the Weir

The erosion processes were threefold:

- Severe bank erosion caused by toe scour
- Stripping back of the turf (sod) layer on the floodplain
- River began to cut a new channel on a shorter course across the floodplain, bypassing a large weir structure

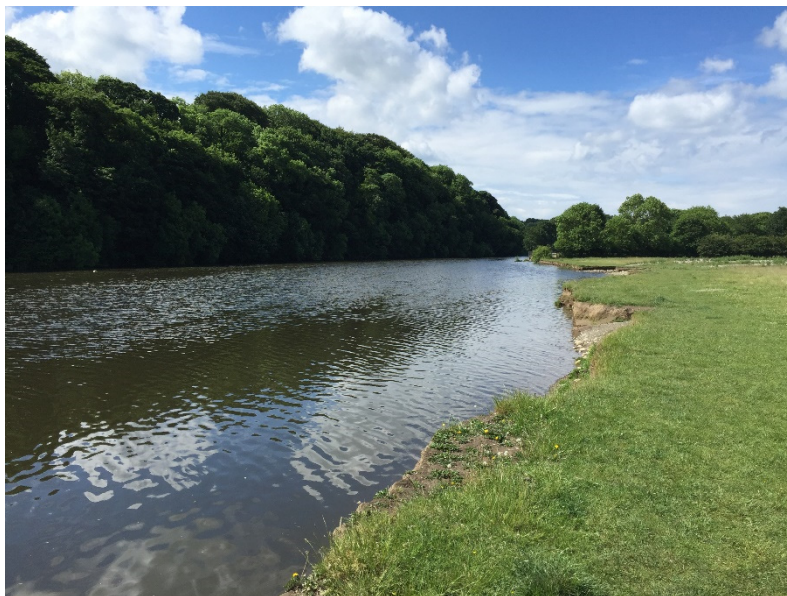
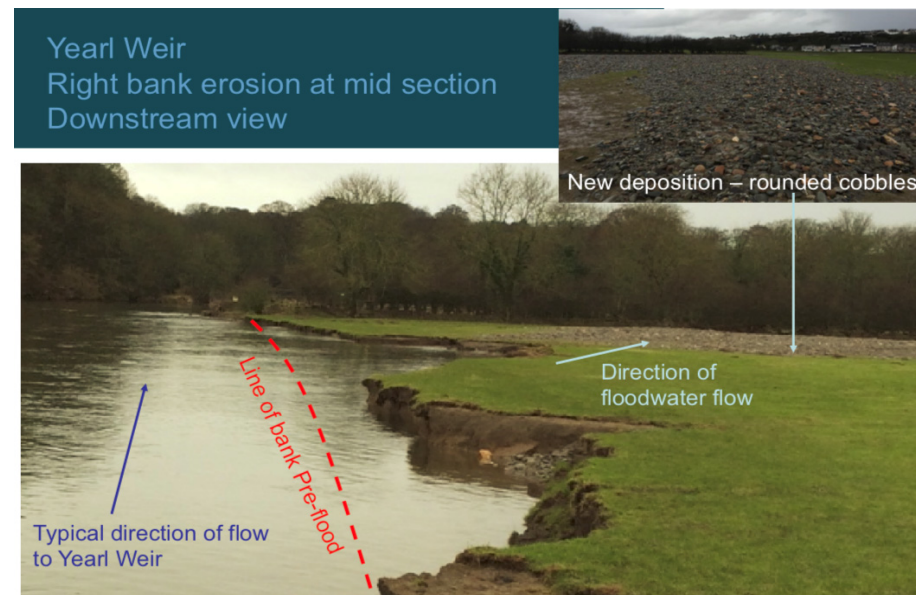
- Records of British Geological Survey indicate site is underlain by alluvium and river terrace deposits over carboniferous pennine middle coal measure
- Further ground investigation and geomorphological survey concludes that fine week alluvial soils that were highly erodible with the alluvium found to comprise 'dark grey' and 'brown' fine to coarse sands
- Vegetation structure was heavily grazed agricultural and the eroding banks were devoid of any vegetation cover at all

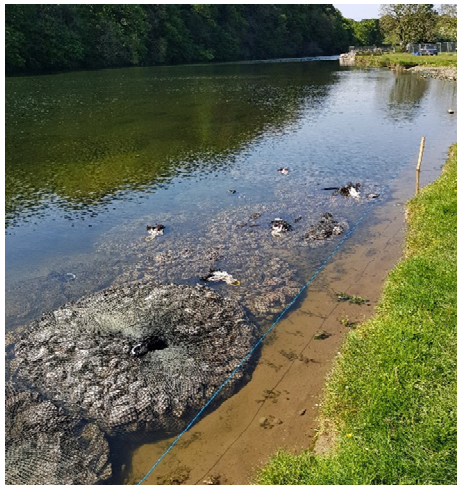
AquaRockBag® installation into deep scour pool. The bioengineering element can then be built up at and above average low water level.

- The scour pools provided a particular challenge, as bioengineering techniques would not control the rate of erosion in 2-3 metres of water
- Rip-rap stone ruled out due to geomorphological impact downstream and the adverse ecological impact
- The solution to controlling the erosion in the scour pools came in the form of AquaRockBags® combined with further bioengineering elements
